NASA CR-135448
PWA-5512-21

PERFORMANCE DETERIORATION
BASED ON EXISTING (HISTORICAL) DATA
JT9D JET ENGINE DIAGNOSTICS PROGRAM

UNITED TECHNOLOGIES CORPORATION
Pratt & Whitney Aircraft Group
Commercial Products Division

Prepared for
NATIONAL AERONAUTICS AND SPACE ADMINISTRATION

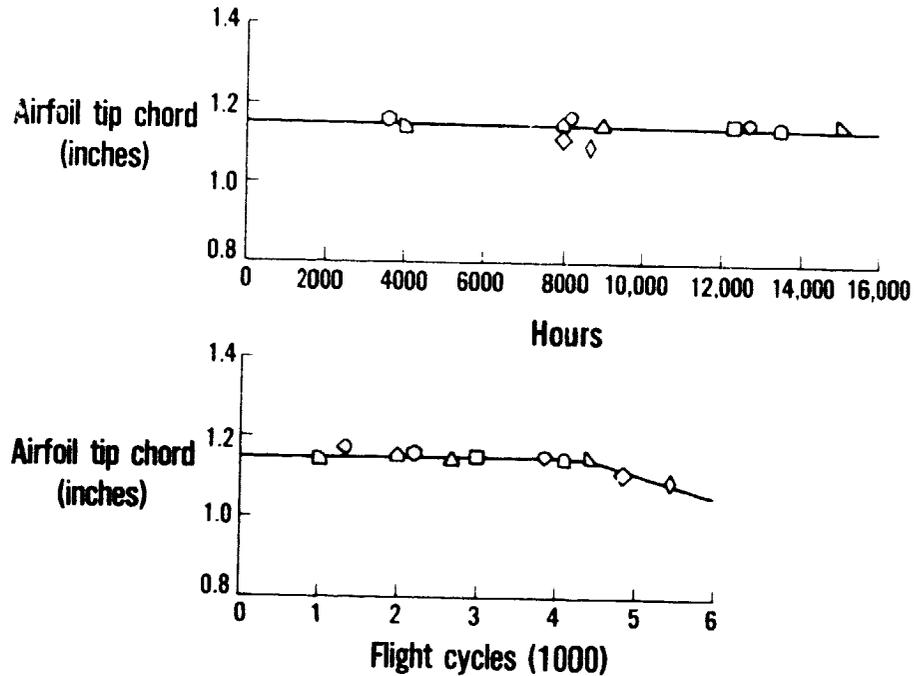
Figure 66 Chord Erosion Data for Tip Region of Fourteenth-Stage Blade - These data show that erosion is a function of cycles, not hours.

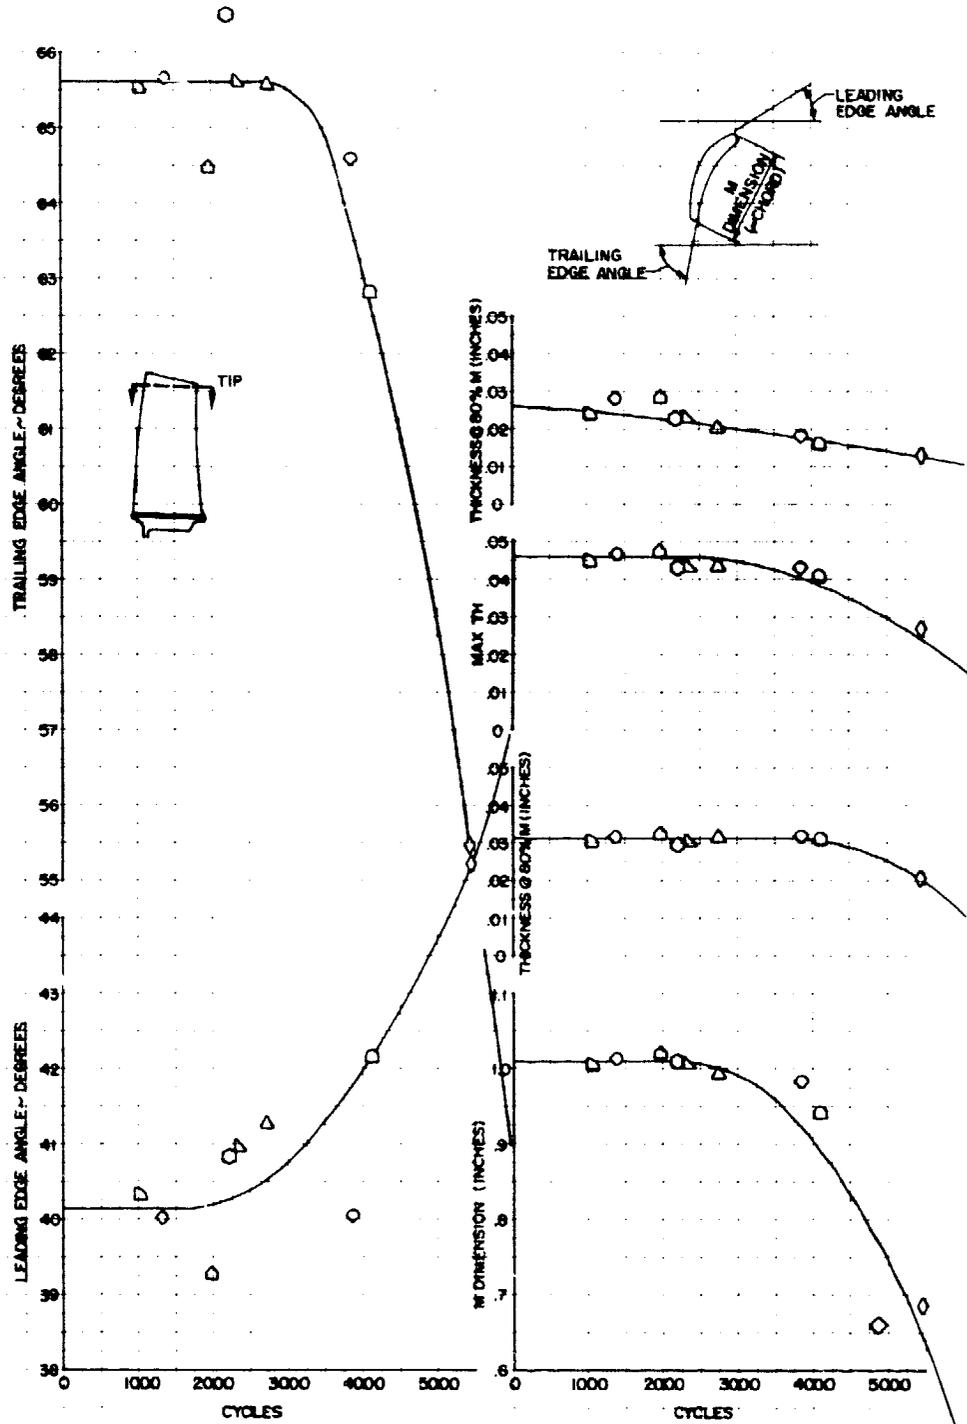
Figure 67 Airfoil Geometry Changes for Tip Section of Ninth-Stage Rotor Blade - The ninth-stage blade tips experienced large changes in leading and trailing edge angles.

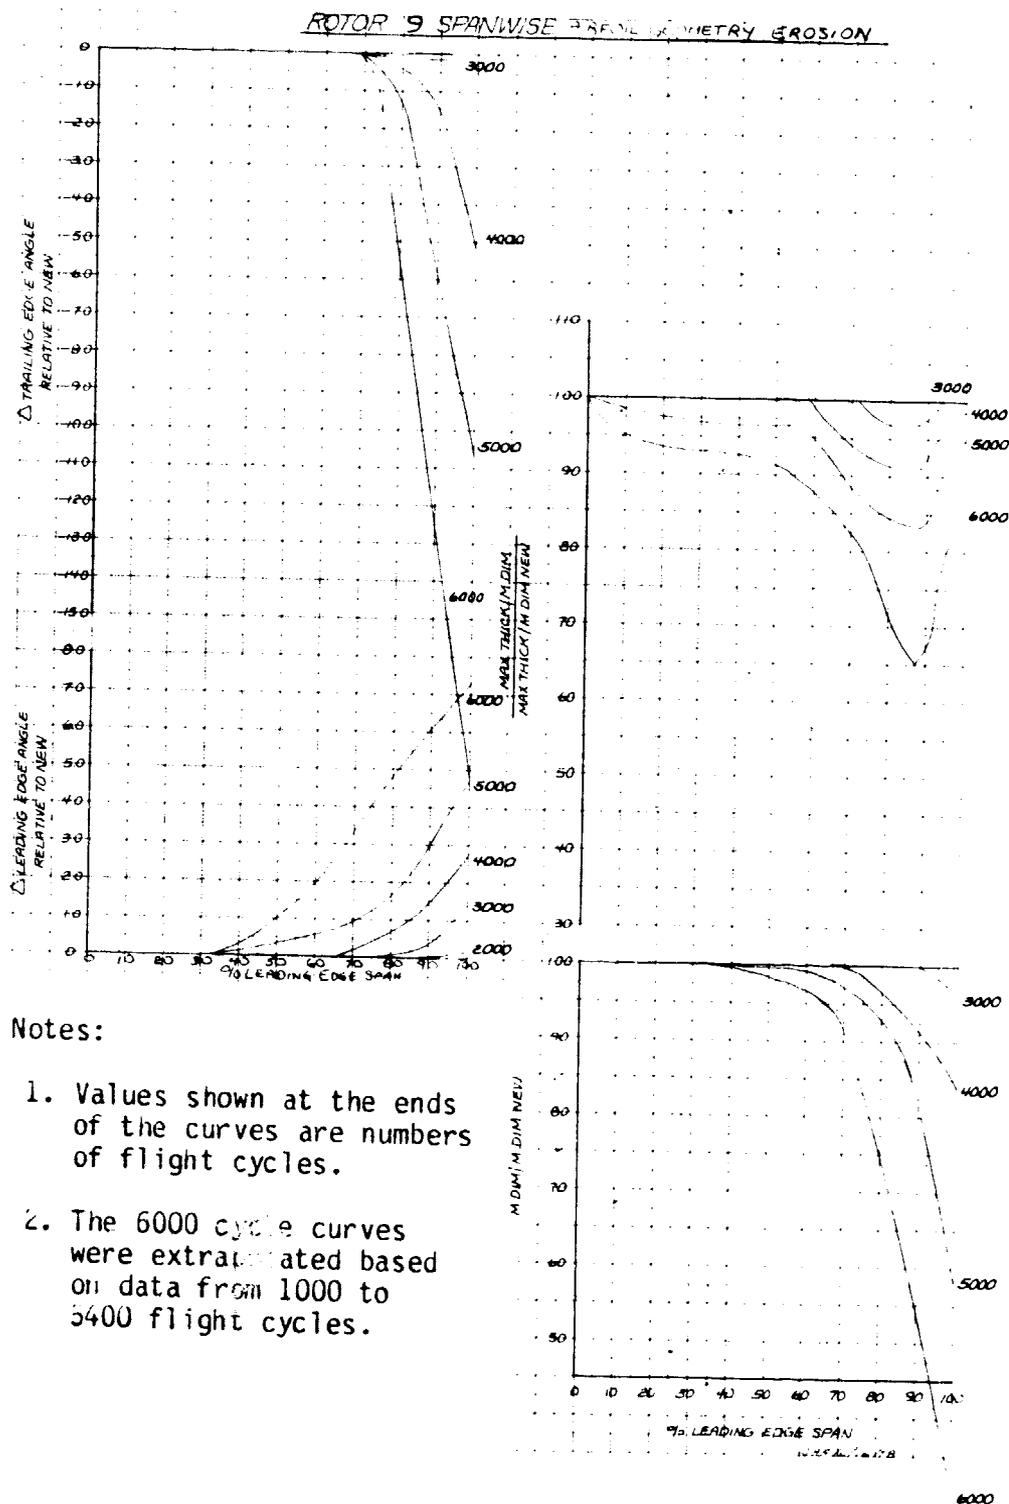
Figure 68 Airfoil Contour Changes as a Function of Leading Edge Span (Ninth-Stage Rotor Blades) - The ninth-stage blades experienced the contour changes, predominately at the tip.

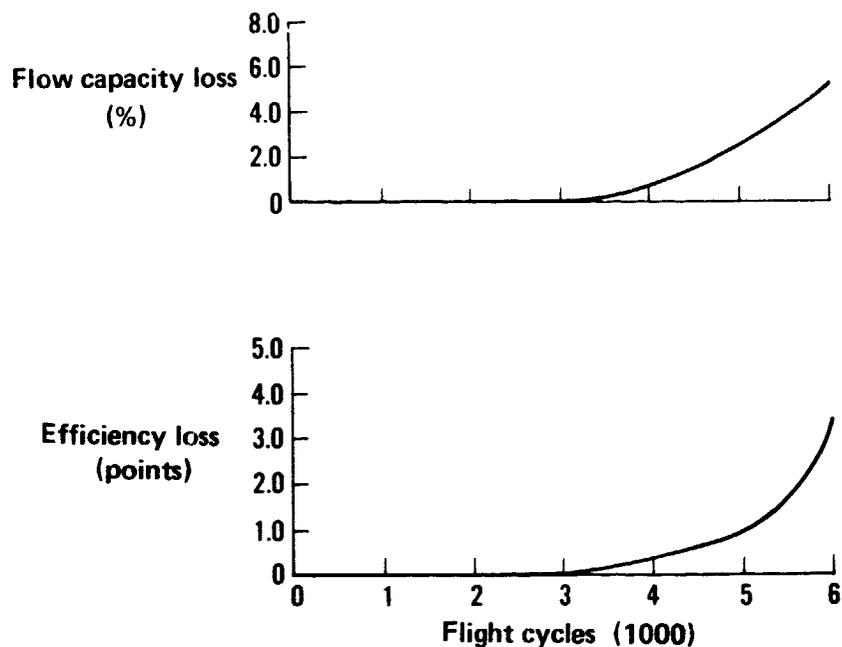
Figure 69 Estimated Effect of Airfoil Contour Changes on Performance - Contour changes produced by erosion have negligible effect on performance during the first 3000 cycles, but at 6000 cycles they produce an efficiency loss of 3.5 percentage points and an airflow loss of 5 percent.

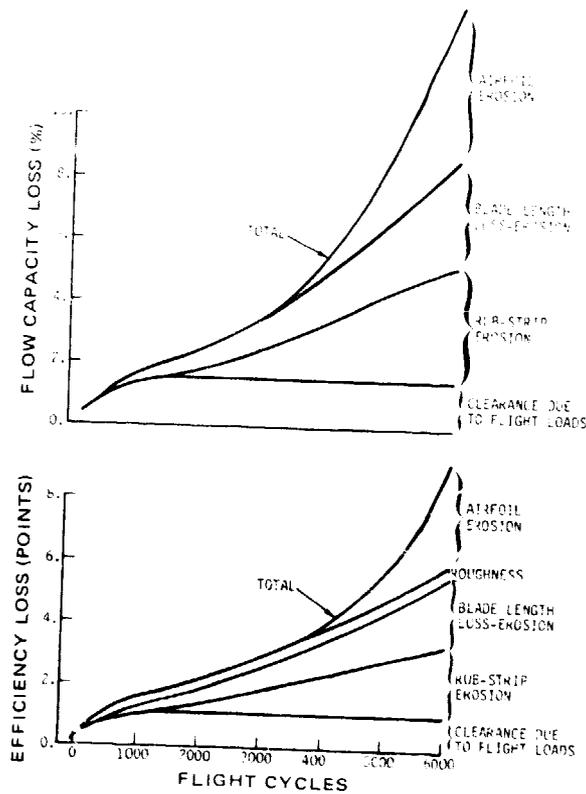
Figure 70 Total High-Pressure Compressor Performance Deterioration - At low-to-moderate age, the majority of the deterioration is caused by rub-strip wear, while at high age, airfoil contour erosion becomes increasingly dominant.

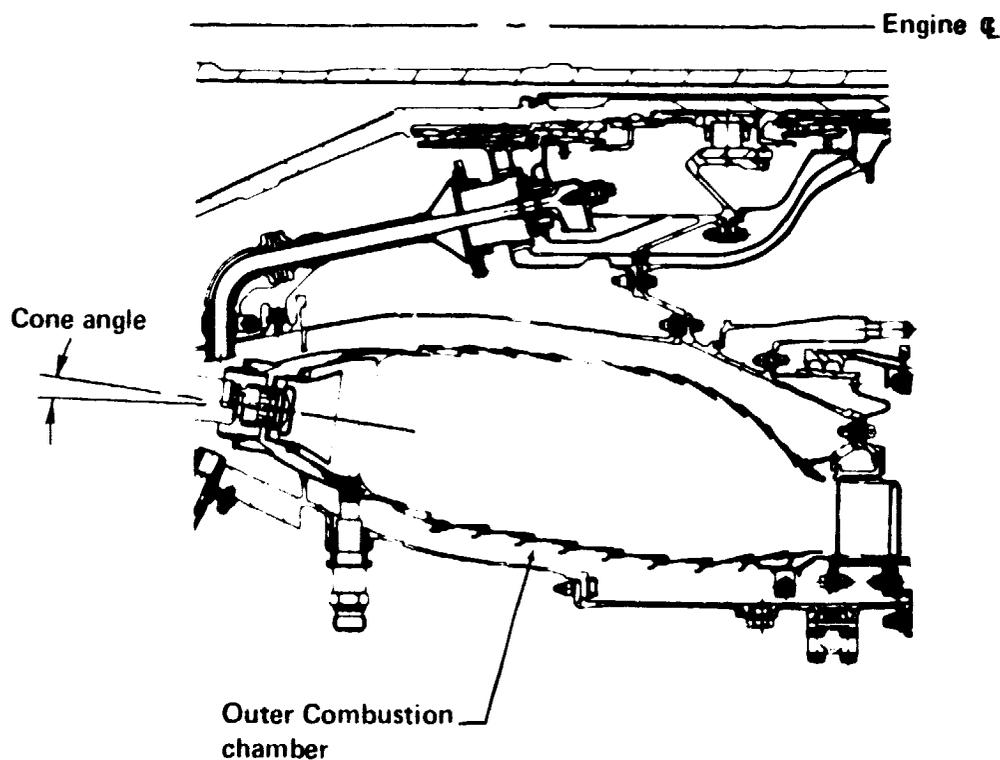
Figure 72 Definition of Combustor Cone Angle - Deviations from the optimum cone angle may result in an adverse radial temperature profile at the turbine entrance.

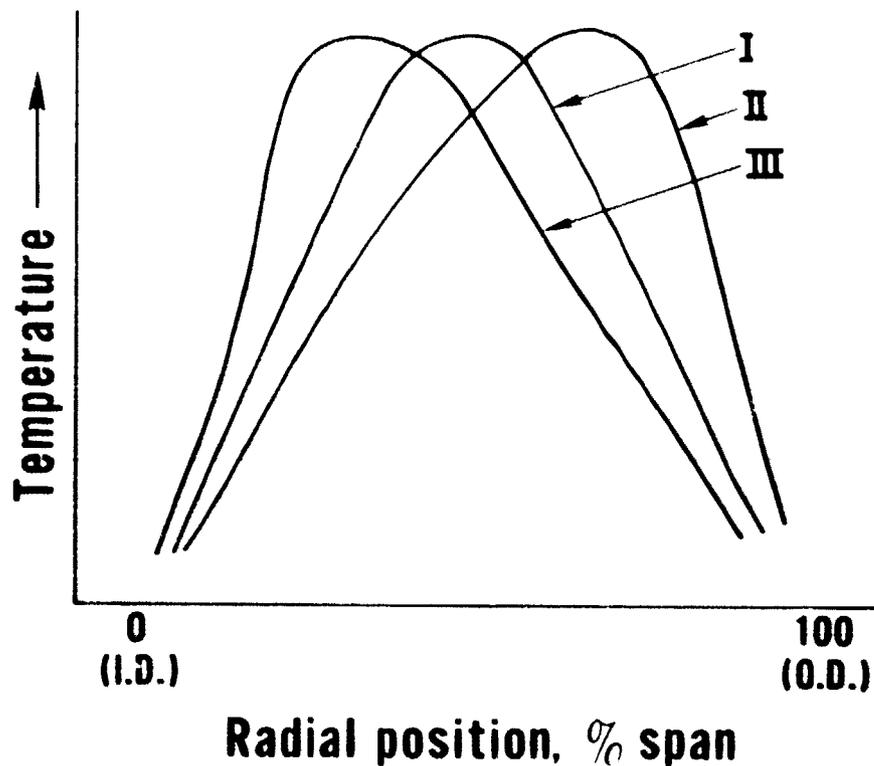
Figure 73 Combustor Radial Temperature Distributions - Distribution I is typical for a properly operating combustor, while distributions II and III may result in adverse conditions in the turbine.

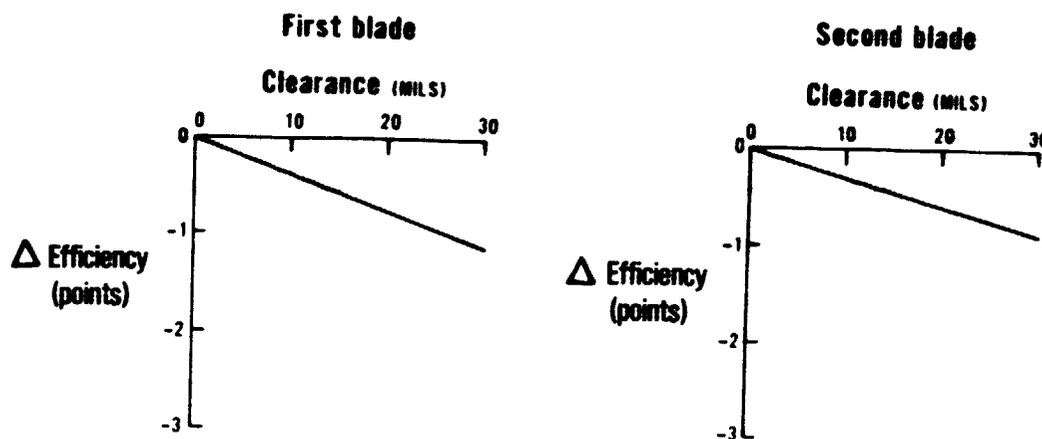
Figure 74 Effect of High-Pressure Turbine Blade Tip Clearance on Turbine Performance - Relatively small changes in tip clearance produce significant losses in turbine performance.

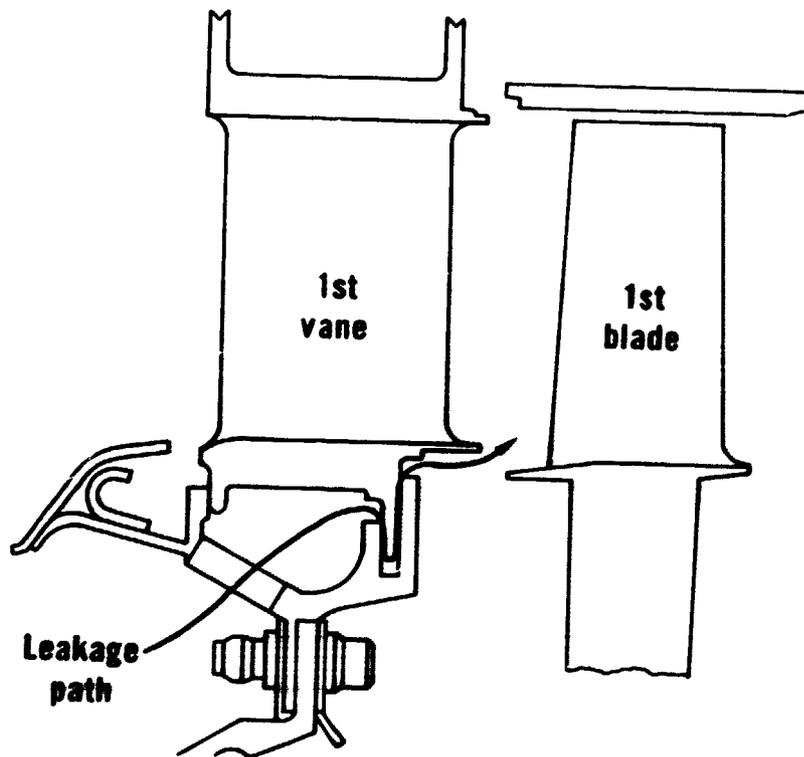
Figure 75 High-Pressure Turbine First-Stage Vane Leakage Path - Vane distortion can result in leakage under the vane platform.

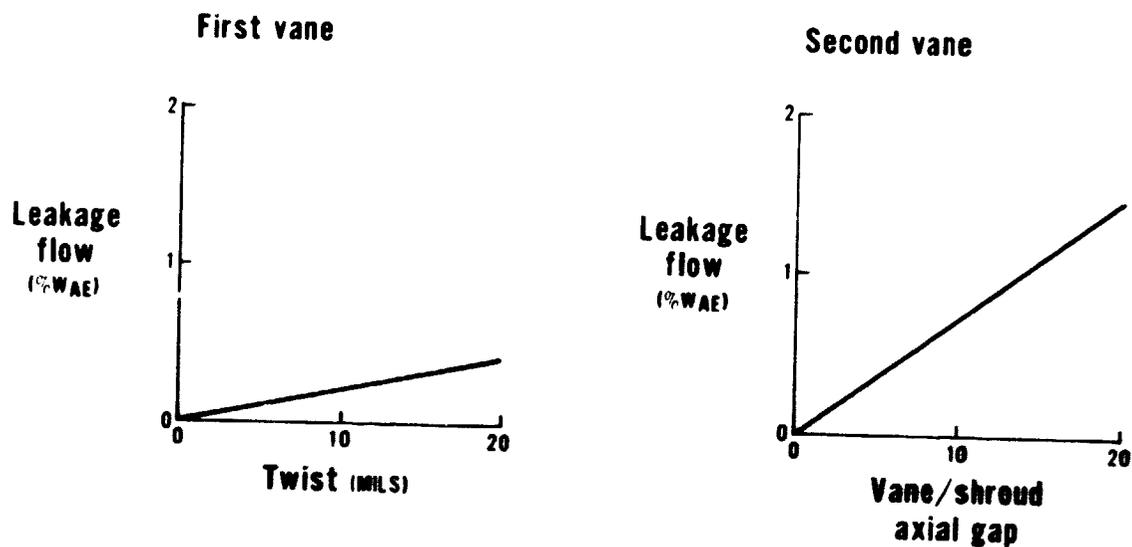
Figure 77 Analytical Estimate of High-Pressure Turbine Vane Leakage Levels as a Percent of Engine Airflow - Significant leakage flows can result from vane distortion.

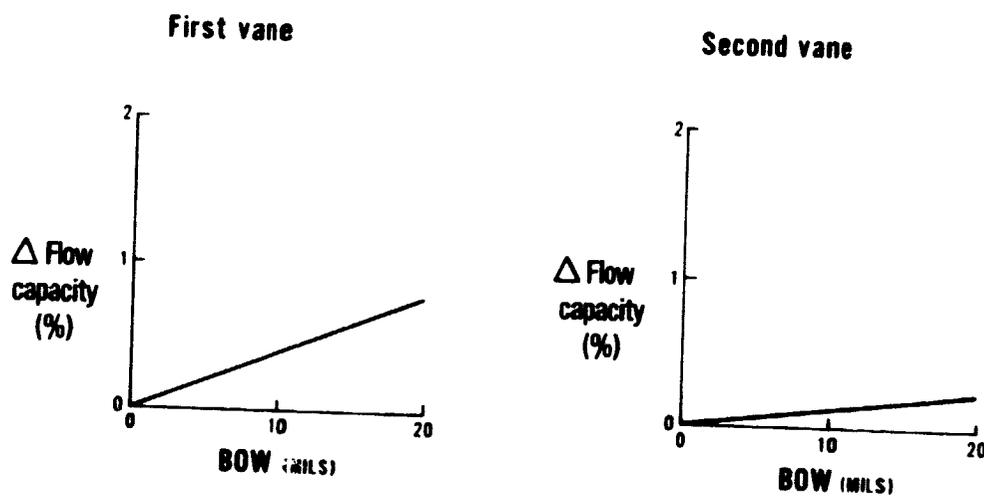
Figure 78 Analytical Estimate of High-Pressure Turbine Flow Capacity Change Produced by Vane Bowing - Vane bowing changes the turbine flow capacity which in turn changes the engine cycle pressure ratio and TSFC.

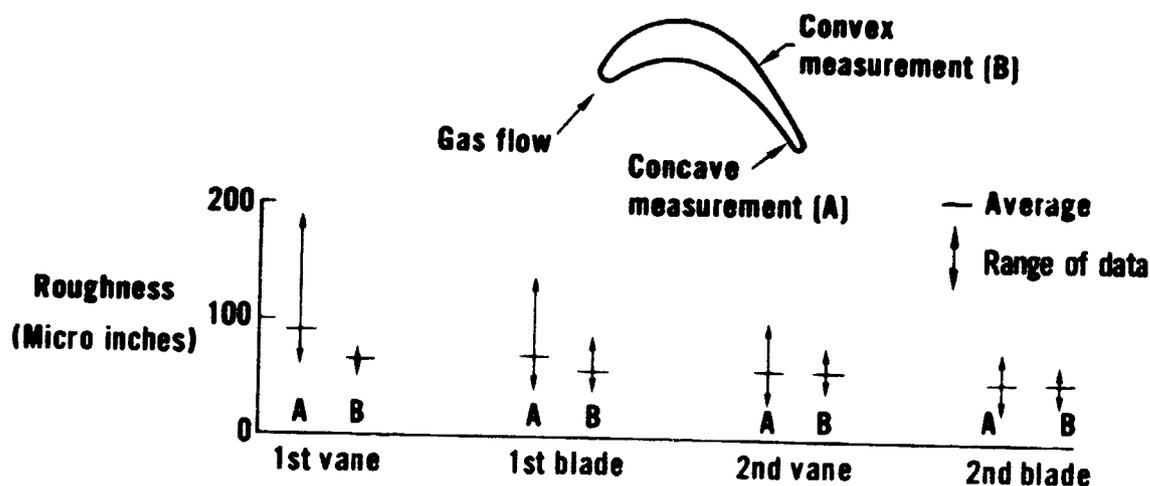
Figure 79 High-Pressure Turbine Surface Roughness Measurement Results - The greatest roughness levels occur on the concave surfaces and in the upstream stage.

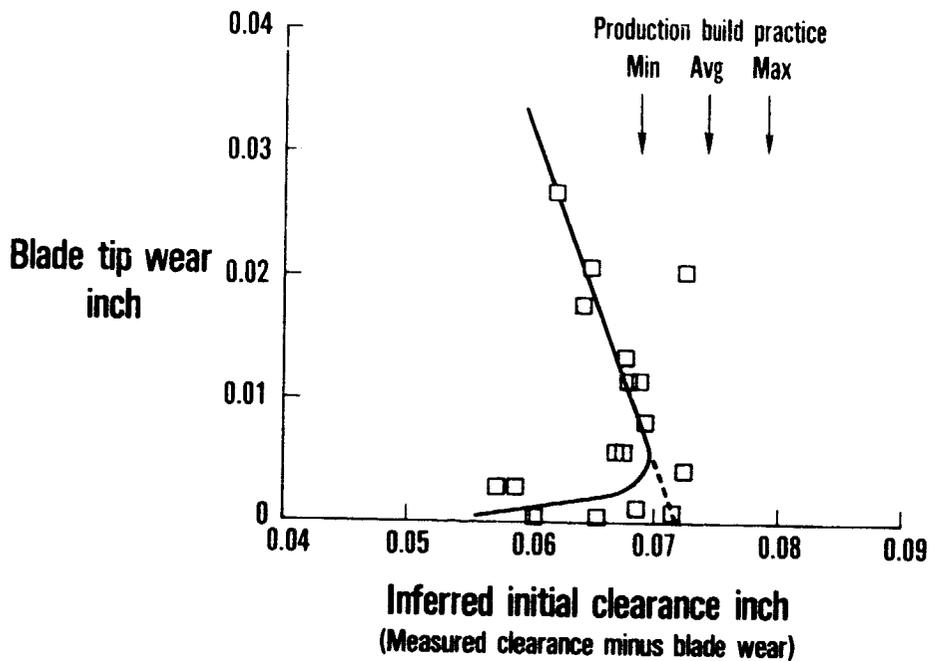
Figure 81 Correlation of High-Pressure Turbine First-Stage Blade Tip Wear With Inferred Initial Clearance - The data indicate that initial build clearances below 0.073 inch expose the turbine to rubbing and substantial tip wear.

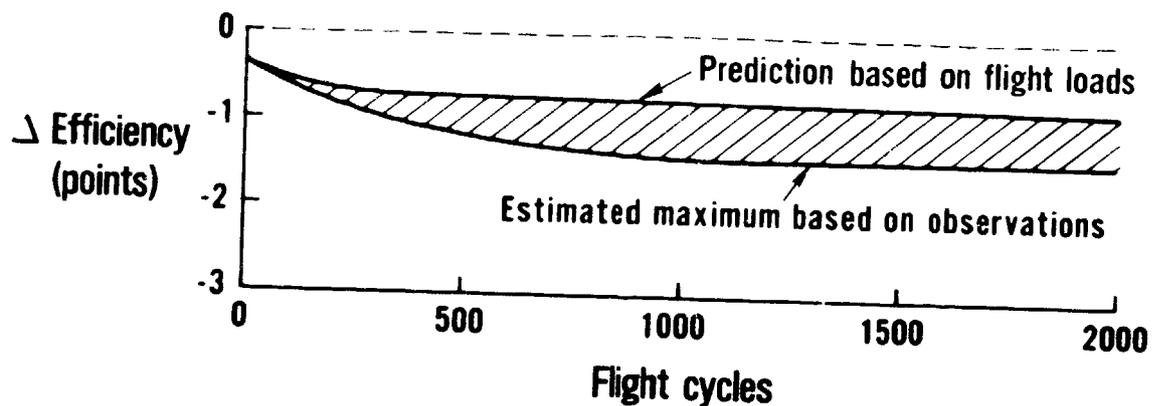
Figure 82 Predicted High-Pressure Turbine Performance Deterioration - Tip clearance changes are estimated to produce more than one percentage point deterioration in turbine efficiency.

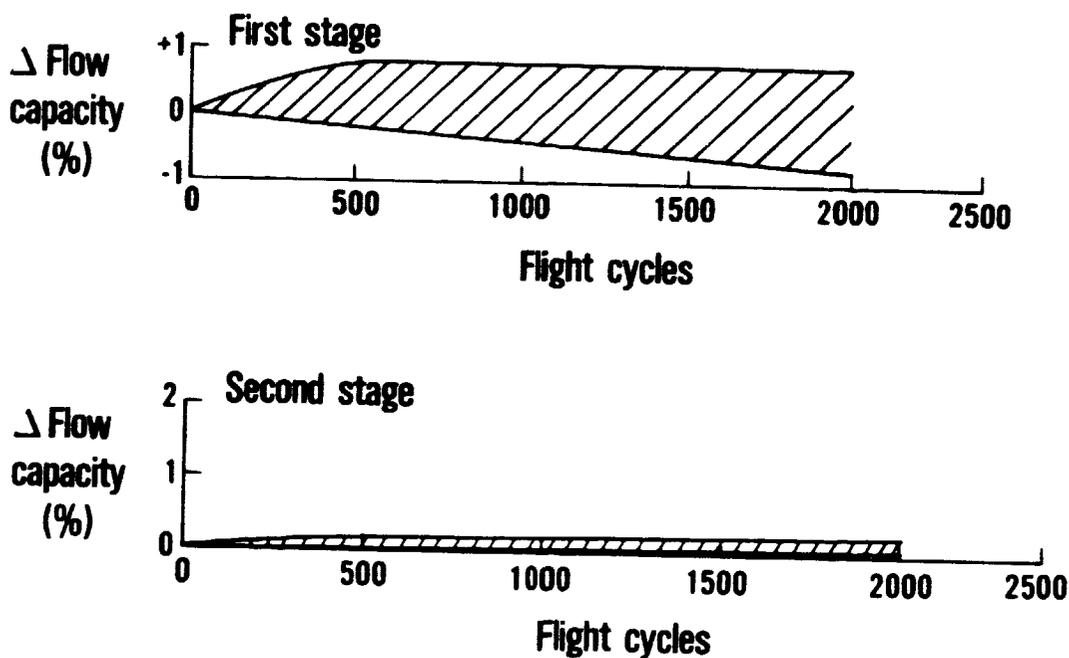
Figure 84 High-Pressure Turbine First- and Second-Stage Flow Capacity - Vane bowing results in approximately 0.2 percent increase in flow capacity in the first stage and 0.1 percent in the second stage.

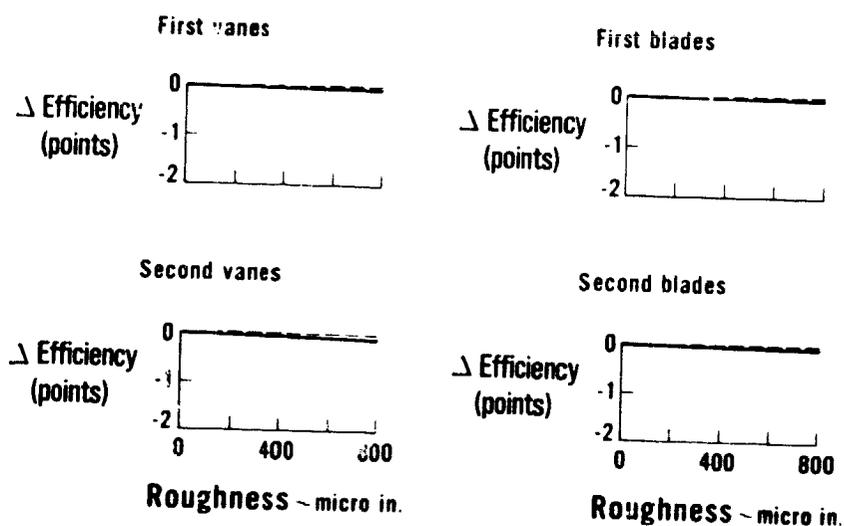
Figure 85 Estimated High-Pressure Turbine Efficiency Loss Associated With Surface Roughness - Extremely high levels of airfoil roughness would be required to produce any significant effect on high-pressure turbine performance.

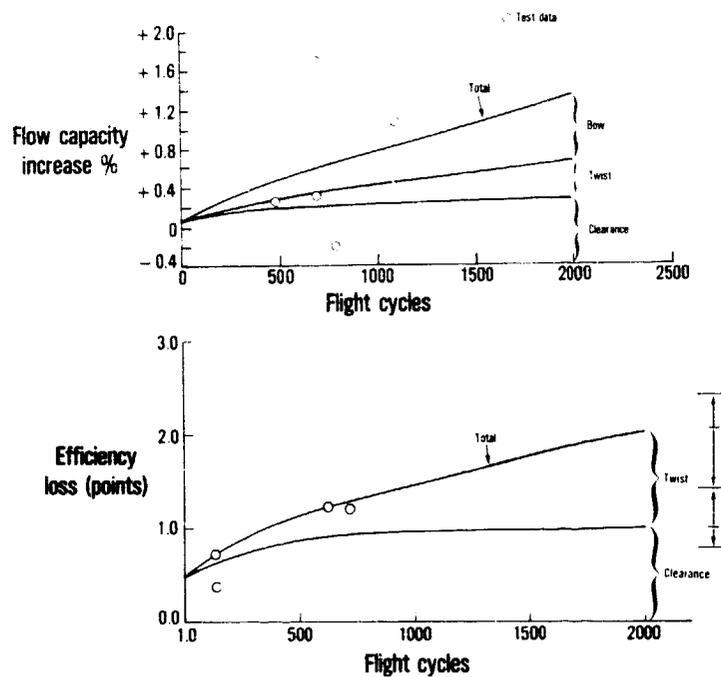
Figure 86 High-Pressure Turbine Overall Performance Deterioration - Back-to-back performance testing shows substantial variation in flow capacity, possibly because of pressure profile shifts.

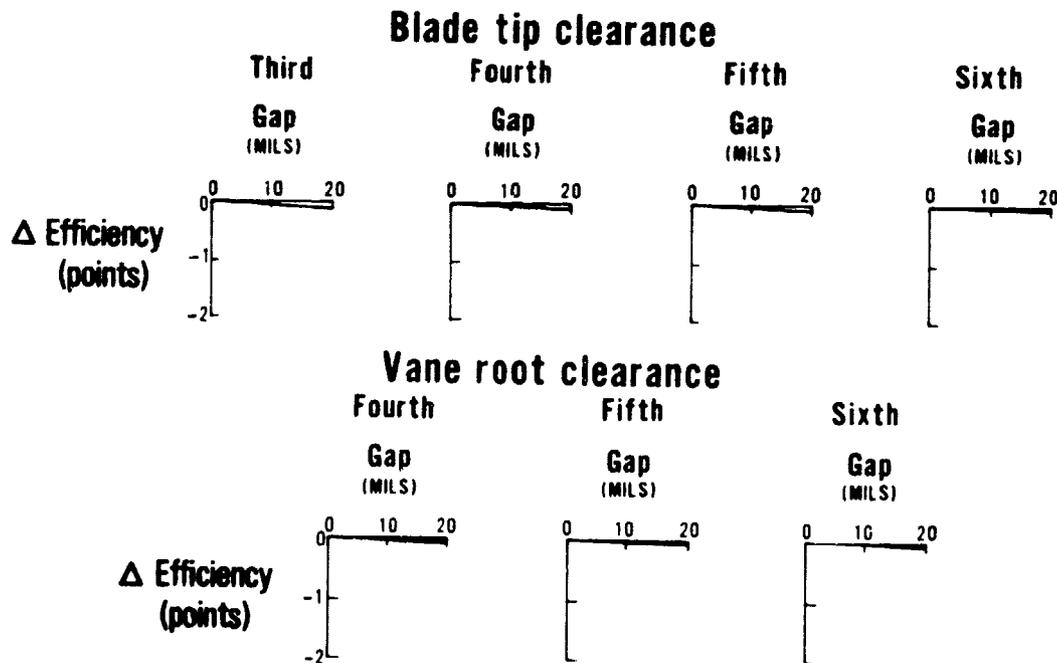
Figure 87 Effect of Blade Tip Clearance on Low-Pressure Turbine Efficiency - The combined effect of a 0.020-inch clearance change in all stages would be significant even though the effect of a clearance change in one individual stage would be very small.

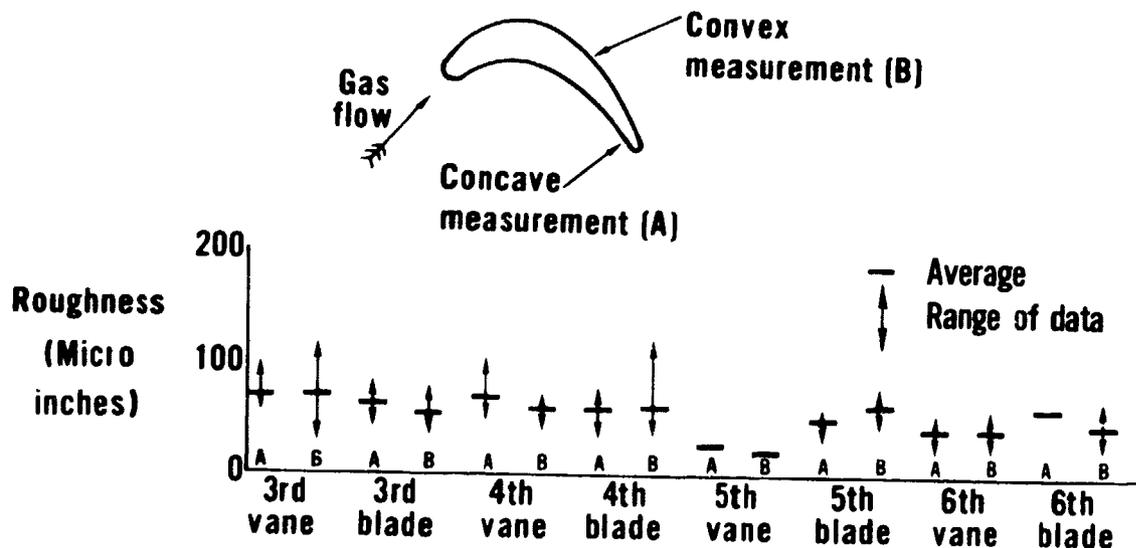
Figure 91 Low-Pressure Turbine Airfoil Surface Roughness Measurement Data - The range of roughness in the low-pressure turbine is much less than that in the high-pressure turbine.

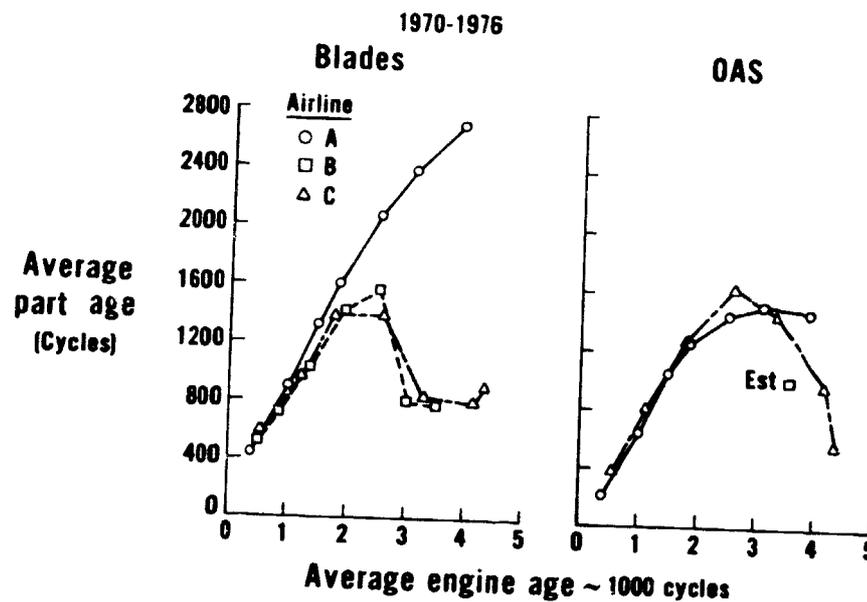
Figure 95 JT9D Fan Module Part Age - For the fan, average part age for Airline A is significantly higher than that for the other airlines studied.

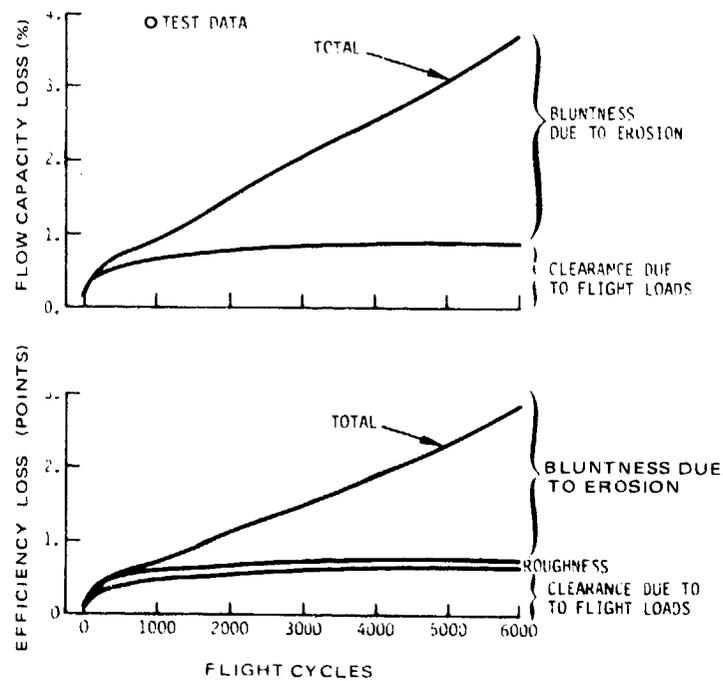
Figure 96 Fan Module Performance Vs. Module Age - Plots such as these were used to establish the relationship between module age and performance deterioration.

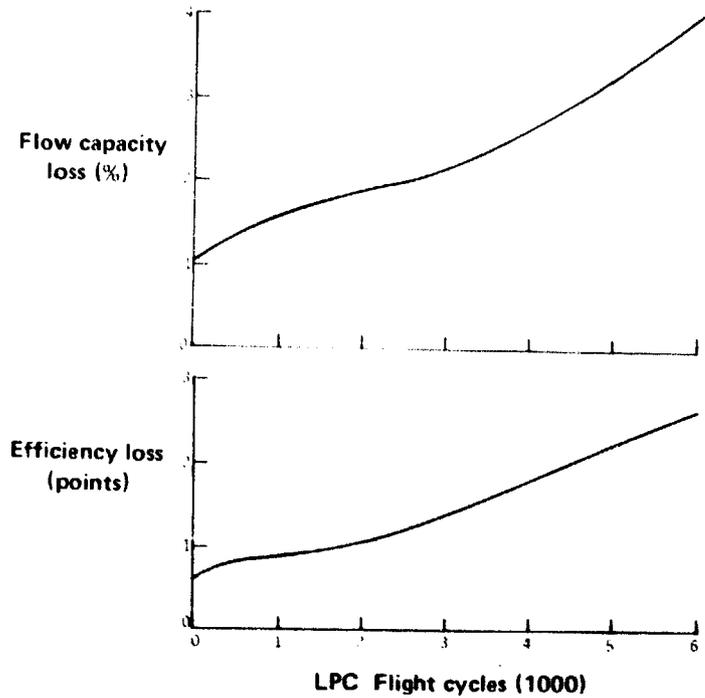
Figure 98 Preliminary Model of JT9D Low-Pressure Compressor Performance Deterioration - The model was developed from part inspection results with the deterioration level corroborated by back-to-back test data and analysis of prerepair test data.

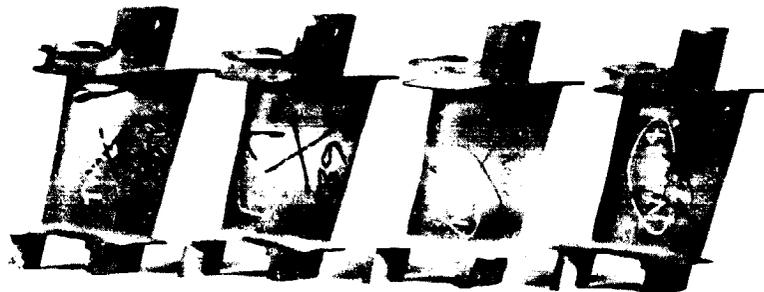
Figure B-35 JT9D Second-Stage High-Pressure Turbine Vanes.

Hours	2900	3500	5600	6500
Cycles	580	785	1640	1935

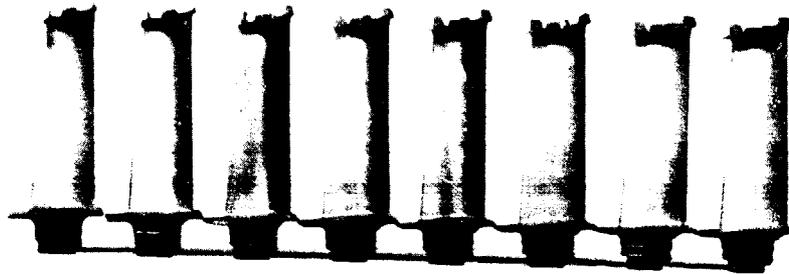
Figure B-36 JT9D Second-Stage High-Pressure Turbine Blades.

Hours	3000	3615	4400	6835	7870	9,655	12,200	13,500
Cycles	565	1000 est	1330	1800 est	2000 est	2,500 est	3,200 est	3,500 est

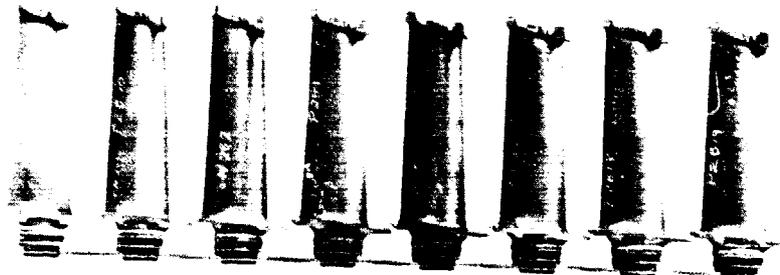
Figure B-37 JT9D Second-Stage High-Pressure Turbine Blades.

Hours	3000	3615	4400	6835	7870	9,655	12,200	13,500
Cycles	565	1000 est	1330	1800 est	2000 est	2,500 est	3,200 est	3,500 est
